U.S. Department  
of Transportation  
**Federal Aviation  
Administration**

# **General Aviation Airworthiness Alerts**

**AC No. 43-16**

**ALERT NO. 228  
JULY 1997**

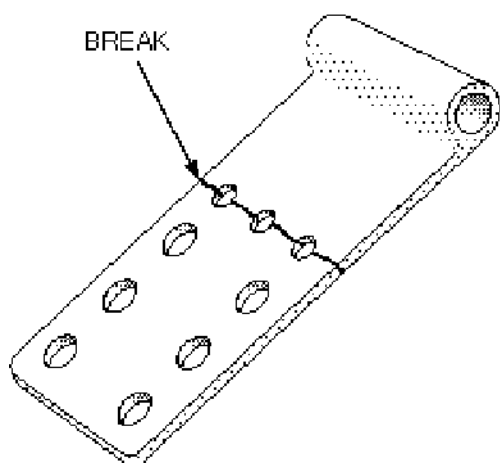
<b>Cessna</b>	<b>Broken Cabin Door</b>
<b>Model 441</b>	<b>Hinge</b>
<b>Conquest</b>	<b>5210</b>

The lower cabin entrance door failed as a person of moderate weight was exiting the aircraft.

During an investigation, the lower cabin door aft hinge (P/N 5111515-15) was found broken. It appeared the hinge had suffered a previous partial crack as indicated by a dark fracture surface which extended from one edge of the hinge through the nearest rivet hole. This door installation had been modified in compliance with Service Bulletin (SB) PJ81-21. SB PJ81-21 adds three rivets to the six original fastener pattern. (Refer to the following illustration.)

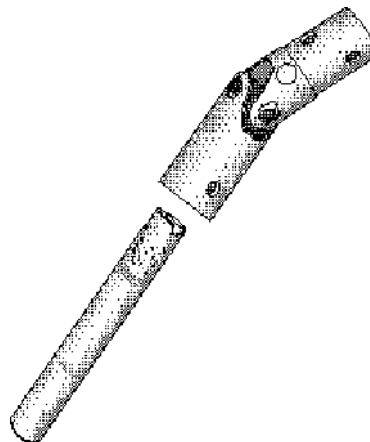
<b>Piper</b>	<b>Control Yoke Defect</b>
<b>Model PA 32-300</b>	<b>2701</b>
<b>Cherokee Six</b>

In the process of replacing the flight control column universal joint (P/N 62834-02), the shaft was found "misdrilled."

The control column shaft (P/N 62716-xx), which fits into the universal joint, was apparently improperly drilled during manufacture. The improperly drilled hole is used to attach the shaft to the universal joint. The hole was drilled at the end of the shaft with approximately half of the hole being in the metal and the other half exposed. (Refer to the following illustration.) The submitter cautioned operators to check the "feel" of the control yoke and have any abnormality investigated by maintenance personnel.

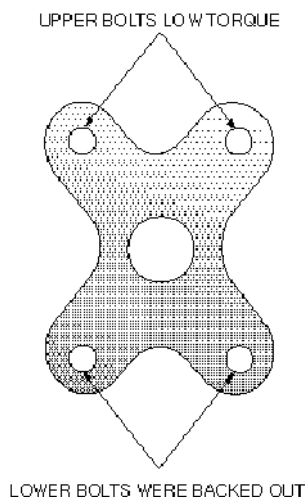
**Main Landing Gear  
Defect  
3211**

During a scheduled inspection, the right main landing gear forward trunnion plate was found to have excessive wear at the four attachment points.

The bolts (P/N AN4-10A) used to secure the trunnion plate (P/N 67040-13) to the aircraft structure were loose, and the lower two bolts backed out. (Refer to the following illustration.) All four attachment holes in the trunnion plate had been elongated due to the loose fasteners. At the time of this inspection, the two upper bolts had not backed out; however, they were well below the prescribed torque value. Piper Service Bulletin (SB) 956, Part 2, had been complied with. Part 1 of SB 956 requires a recurring check of the bolt torque at 100-hour intervals. Part 2 of SB 956 terminates the recurring torque check by enlarging the four holes to accommodate a larger bolt (P/N AN5-10A). Refer to SB 956 for specific instructions.

The submitter recommended that all trunnion plate attachment bolts be checked for proper torque, bolt or plate wear, and security during scheduled inspections.

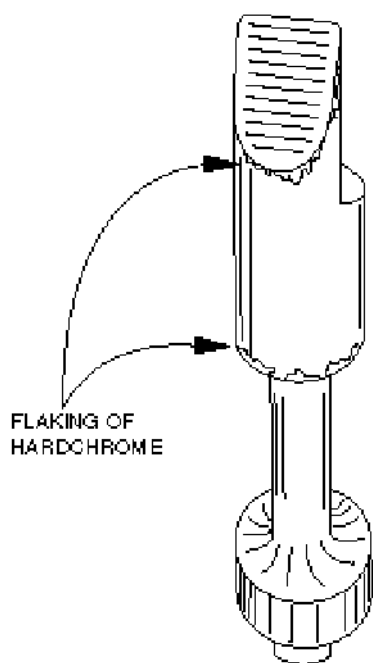
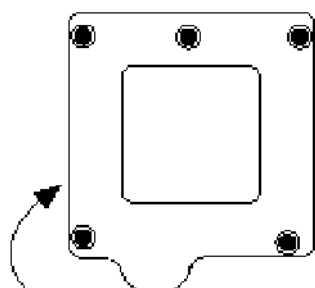
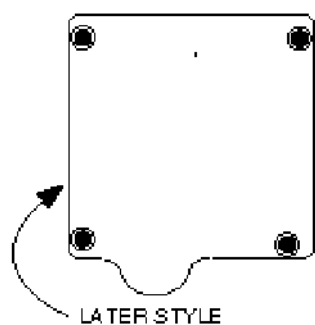
INSPECTION COVERS

**North American                      Landing Gear Failure**  
**Model SNJ-5                      3230**  
**Texan**

The submitter stated that in the morning before these flights, the aircraft had been taken out of a warm hangar and was then subjected to flight altitude temperatures as low as -20 degrees Fahrenheit. Although proper lubrication was present, it was speculated the temperature differential may have contributed to this failure. There was no mention of moisture on or in the area of the locking pin which could have frozen the pin into the “retracted position.” (Refer to the following illustrations.)
